Effects of Vertical Deficiency Location on the Structural Behavior of Steel SHS Short Columns

ABSTRACT: Structures that face damage require strengthening to reach the initial performance. Strengthening steel Square Hollow Section (SHS) short columns with initial deficiencies were not taken into account appropriately. In this paper, vertical deficiencies with the same dimensions were created at three locations (top, middle, and bottom) on the middle element and the middle of the corner element. Then, the effect of the location of such deficiencies on axial behavior of Carbon Fiber Reinforced Polymer (CFRP) strengthened steel tubular columns was investigated. To this end, a total of nine steel columns were experimentally tested and the same specimens were modeled using ABAQUS V.6.14. In the experimental work, a straight pressure test was performed. In the numerical simulation, three dimensional (3D) simulation method, static gradual loading, and non-linear static analysis were used. The specimens were: no deficiency (Control), four non-strengthened columns with deficiencies at different locations, and four CFRP strengthened specimens having deficiencies. The results showed that vert

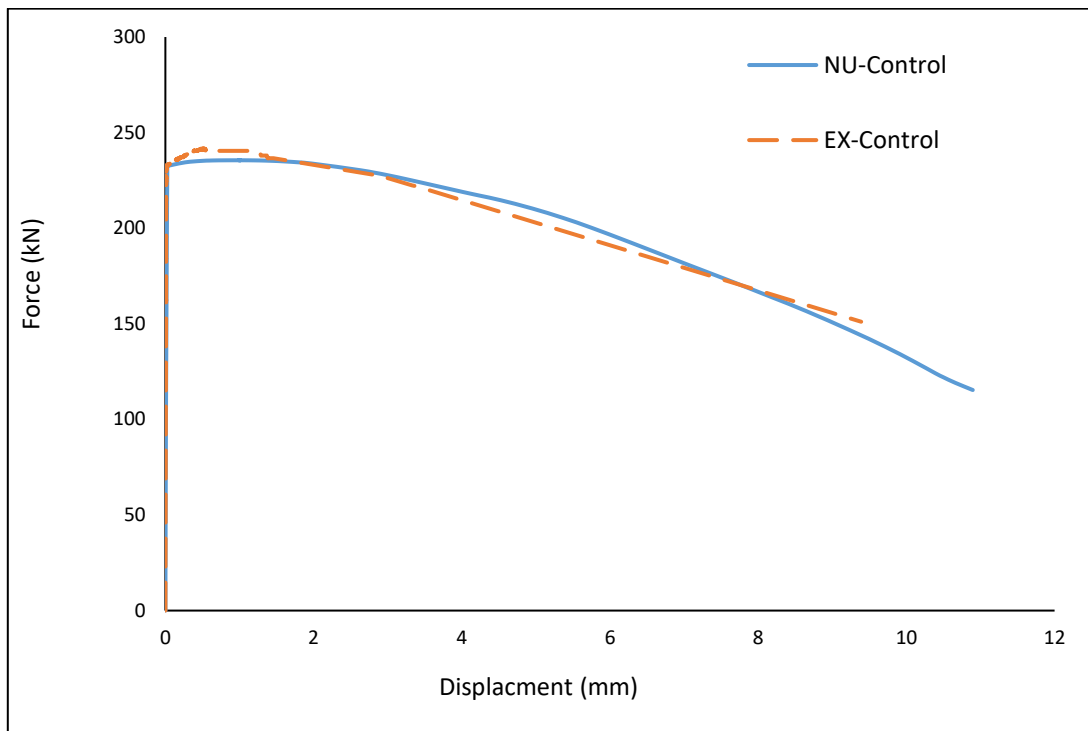
Fig. 4. Force-displacement diagram of steel column with no deficiency

A control specimen (non-strengthened steel columns without deficiency) was used to compare the results. Investigations were based on force-displacement graphs to study the effect of the location of deficiency of steel columns strengthened by CFRP. As it is evident from Table 4, the control specimen tolerated 241 kN as a result of axial load (Fig.4). Also, good agreement between numerical simulation and experimental results is shown in Fig.4.

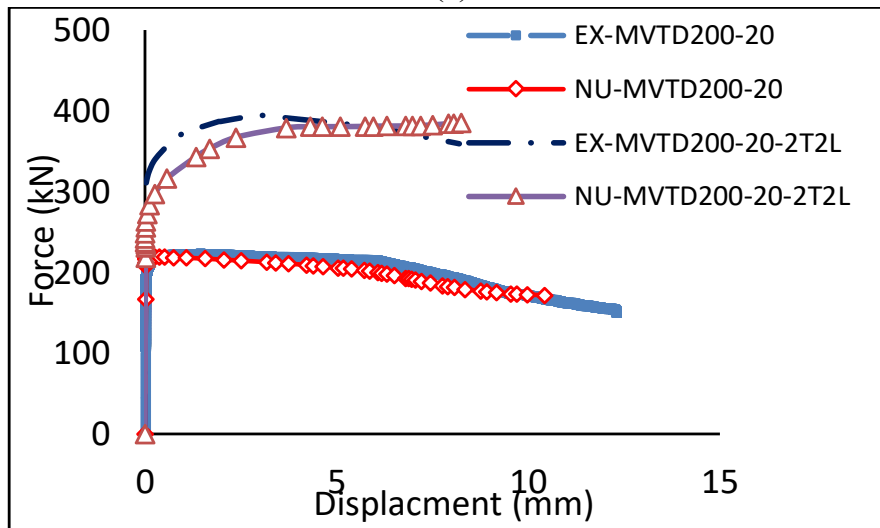
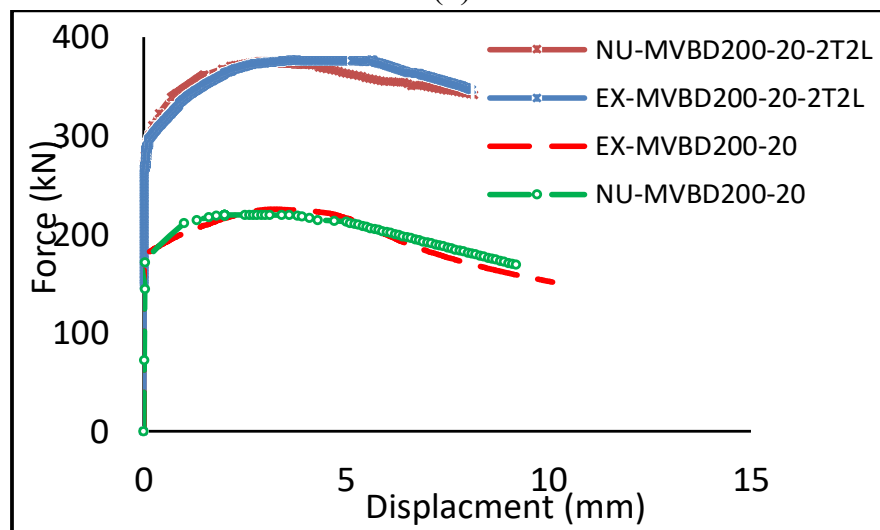
Fig. 5. Force-displacement diagram of the columns with vertical deficiency of middle element (a) top, (b) middle, and (c) bottom

MVTD200-20 is the deficiency at the top of the middle element. As it is shown in Fig.5a, the load-bearing capacity of the damaged column declined by 7.46% compared to the control sample after imposing vertical deficiency. Displacement increased by 9.23% compared to the control sample. Using four longitudinal and transverse CFRP layers coupled with enclosed deficiency area increased the bearing capacity of damaged columns by almost 390 KN, which is 63.48% compared to the control specimen (Fig.5b).

MVD200-20 was the deficiency in the middle of the middle element. Load-bearing capacity and deformation are 12% and 7.46% compared to the control specimen. CFRP strengthening of this specimen increased ductility and bearing capacity by almost 385 KN, which is 62.24% compared to the control specimen. Deficiencies at the bottom of the middle element (MVBD200-20) reduced bearing capacity by almost 219 KN, which is 7.05% compared to the control specimen. Vertical deficiency at this location caused the most critical mode in the middle element. Longitudinal and transverse CFRP strengthening increased bearing capacity by almost 373 KN, which is 56.01% compared to the control specimen (Fig.5C).

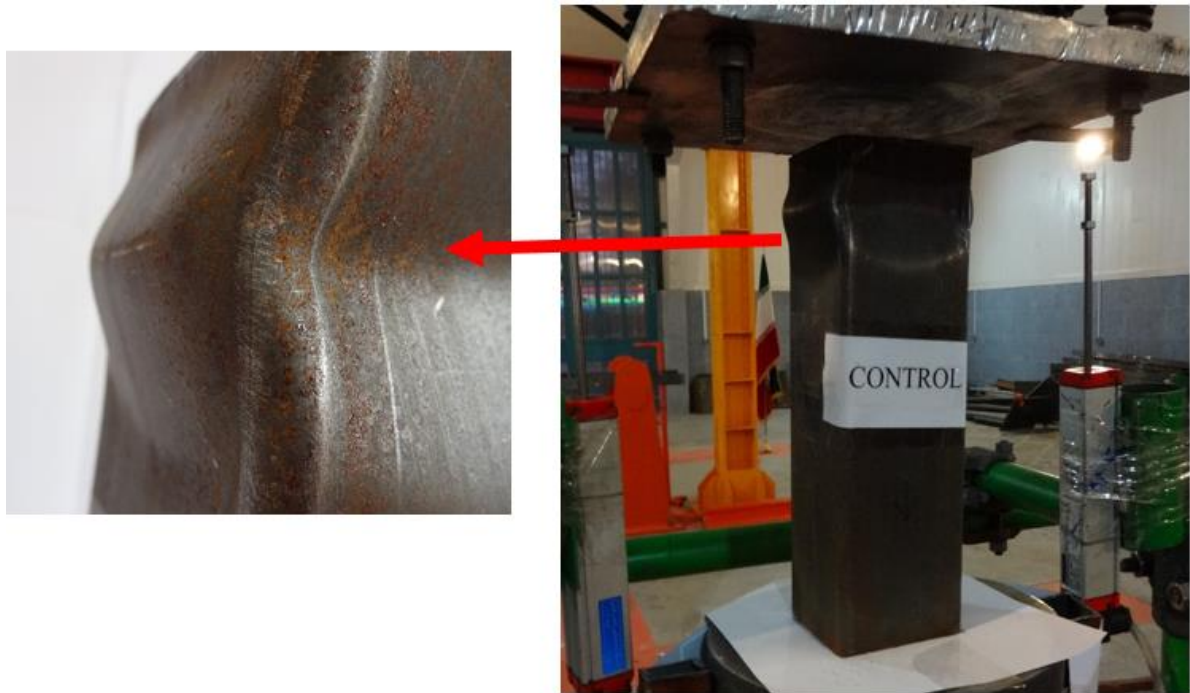
Fig. 7. Failure modes of Control specimen

The behavior and rupture depend on the load-bearing capacity, ductility, and rupture of elements undergoing axial loads. Buckling in the deficiency region is one of the important factors to study the behavior and failure of damaged columns. Firstly, the behavior and rupture of the specimen with no deficiency are studied. Fig.7 shows the control column before and after failure. Elephant Foot Buckling was observed after completing the test, which is mainly associated with prevailing the force over internal elements in the elastic area of the element.

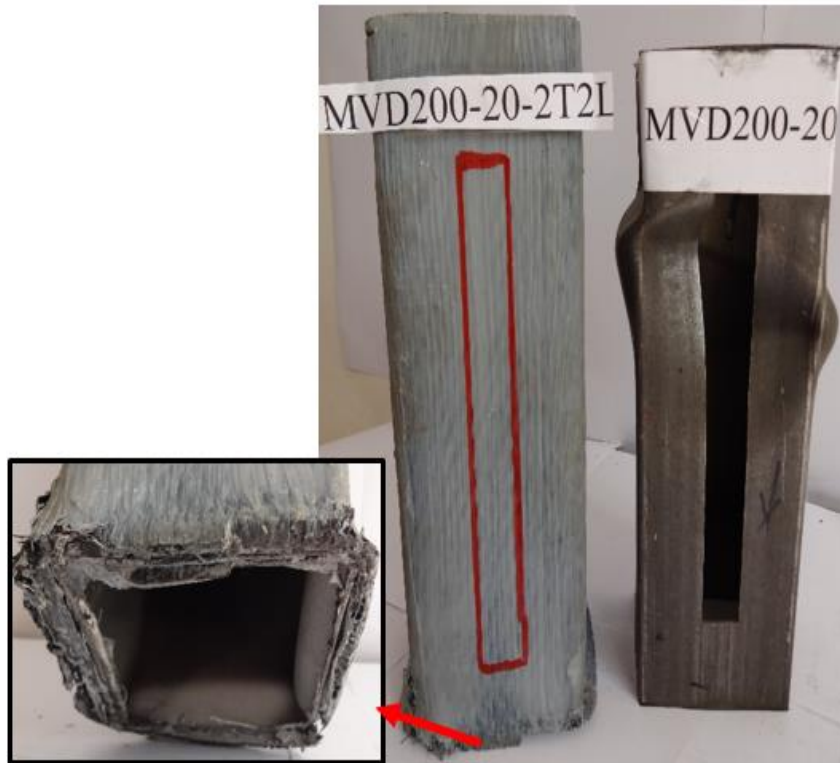
Fig. 9. Failure modes of the specimens with middle deficiency: non-strengthened and strengthened

The vertical deficiency in the middle of the middle element showed that axial loading increased the stress and rupture in the exterior of the steel column. This increasing stress distribution causes axial deformation and local buckling. As it

is evident in Fig.9, steel column strengthening is effective for improving the buckling property performance of the section. CFRP arrangement plays a key role in increased stiffness and ultimate strength of the damaged column. CFRP also reduced the stress distribution by enclosing the deficiency area.

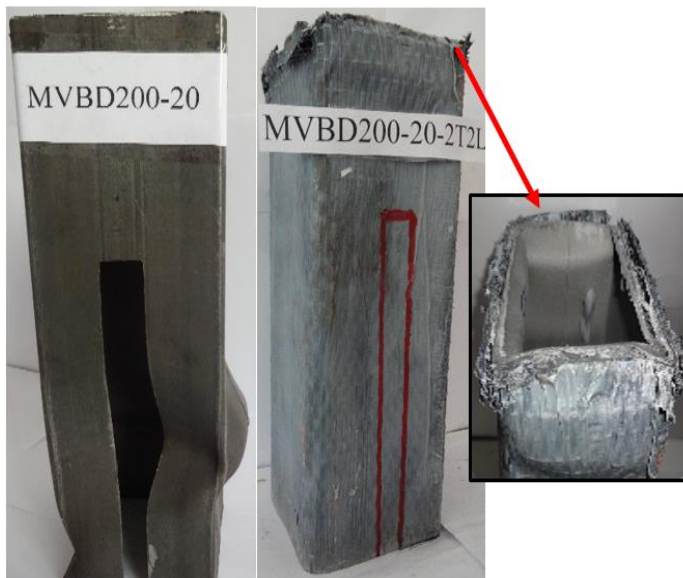
Fig. 10. Failure modes of the specimens with middle-bottom deficiency: non-strengthened and strengthened

Fig.10 shows the vertical deficiency at the bottom of the middle element. As it is clear, the deficiency caused local buckling along with the deficiency and energy absorption limitation. Increasing local buckling along the vertical deficiency caused the maximum stress and strain distribution.

This specimen experienced the most critical situation among the specimens with vertical deficiency. Using four longitudinal and transverse CFRP layers had a significant effect on the strengthening and stiffness of the damaged specimen. As Figure 10 showed, CFRP layers minimized the deformation by wrapping the location of deficiency. On the other hand, increasing vertical loading caused the rupture and CFRP separation exterior to the deficiency. CFRP separation at the top location of the element happened due to increasing local stress and strain distribution.
