Effect of Damping Element Damage under Erosion on Vibration Behavior of an Industrial Gas Turbine Group-Blades

ABSTRACT: The last stage blade rows of modern low-pressure gas turbines are subjected to high static and dynamic loads. The centrifugal forces primarily cause the static loads due to the gas turbine's rotational speed. Dynamic loads can be caused by stationary gas forces, for example. A primary goal in de-signing modern and robust blade rows is to prevent high cycle fatigue caused by dynamic loads due to synchronous or non-synchronous excitation mechanisms. Damping elements are one of the most common structures to alleviate excessive vibration amplitudes in turbomachinery applications. This paper deals with fracture investigations of the gas turbine blade of a 15 MW Gas injection station in the national Iranian South oil company in the southwest of Iran. Macroscopic and scanning electron microscopy images of the fracture section of the tube show two phenomena erosion and fatigue. Therefore, to more accurately identify the cause of the failure, stress and vibration analysis of the blade is performed individually and coupled with other blades by the connecting tube using AN

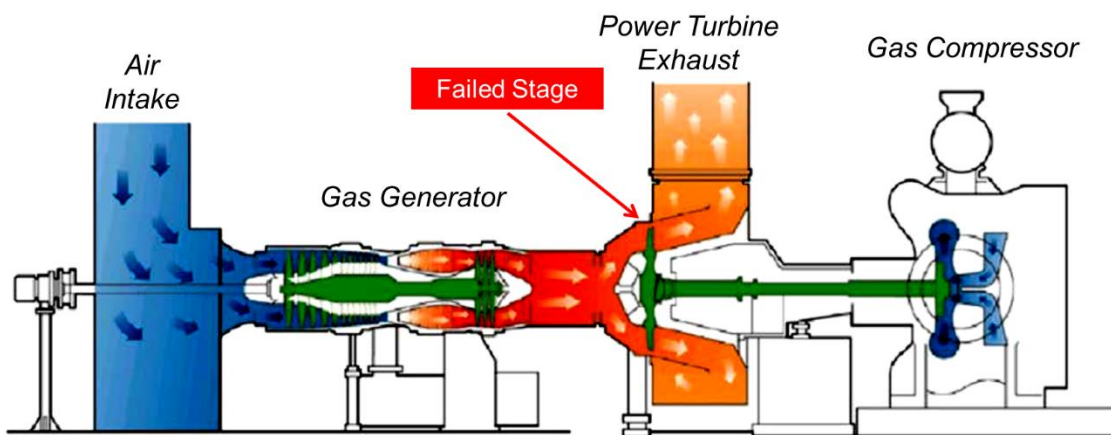
Fig. 1. Gas turbine and power turbine schematic.[34]

The free power turbine serves to convert the gas energy to mechanical rotary energy or brake horsepower. Closely coupled to the gas generator by a transition duct, the power turbine extends the gas generator combustion products through one or two turbine stages and the residual gas energy is exhausted to the atmosphere [33]. The rotative power produced in the power turbine is then available for mechanical couplings to the driven equipment. Fig. 1 shows a cross-section view of the 15MW gas turbine package that was utilized to drive a centrifugal pipeline booster to compress natural gas. Exhaust gas from the hot section of the gas generator is used as a power drive for the turbine, with a temperature of about 637 °C. Fig. 2 shows the general assembly of the relevant power turbine. The first stage of the power turbine consists of 42 blade sets. This stage consists of 6 groups of 6 blades and 2 groups of 5 blades with a damping tube.

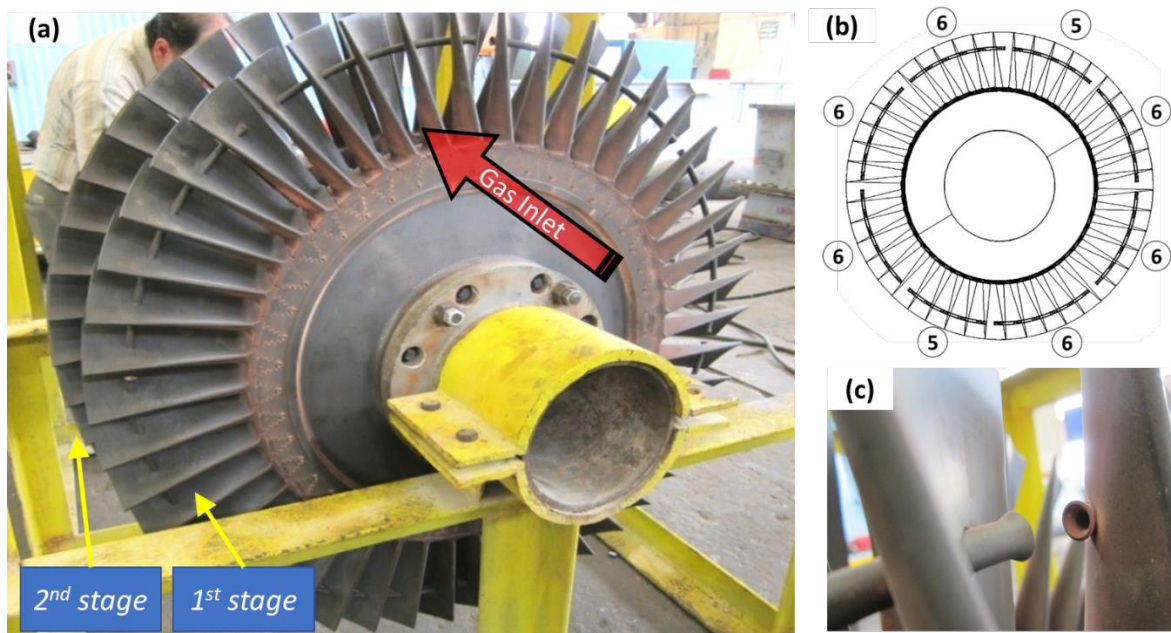
Fig. 2. The desired gas turbine (a) Rotor assembly, (b) Arrangement of a group of blades (c) Connection between damping tube and blade

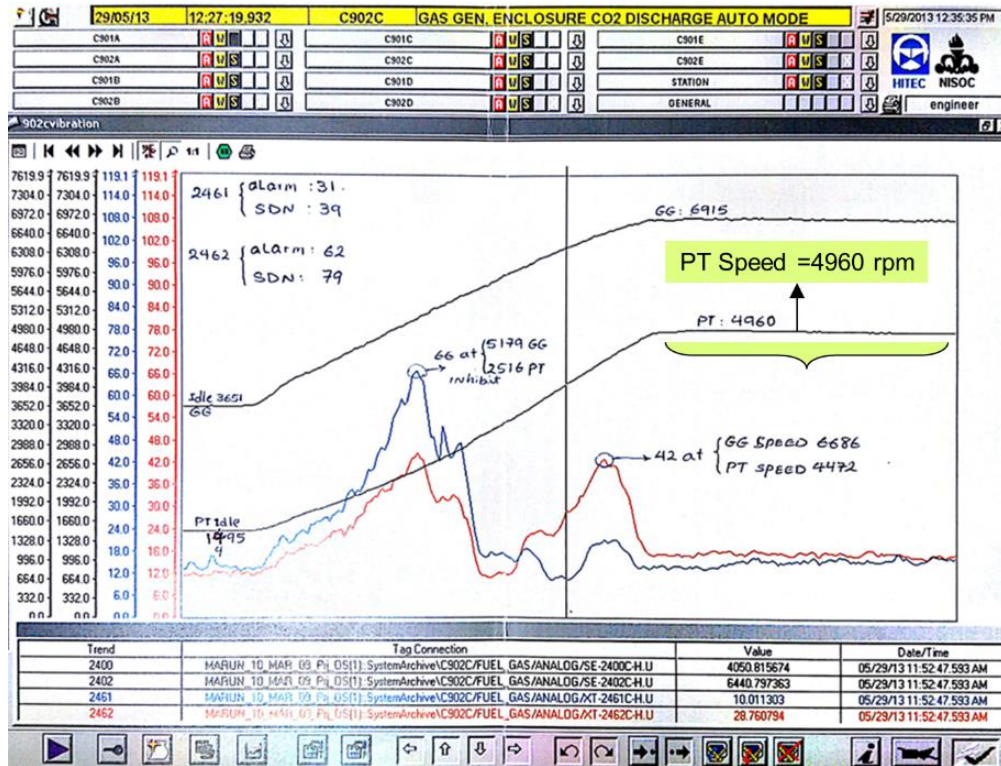
Fig. 3. Parameters recorded by the control room during unit operation

Fig. 3 (the only remaining data of the desired turbine) shows the monitoring parameters by the gas station control room, which include, the gas generator and power turbine rotational speed in startup mode until reaching the nominal speed. The power turbine's nominal speed is 4960 rpm, which will increase up to 5200 rpm. The overspeed power turbine speed is 5500 rpm. The first stage of the power turbine blade made of nickel-based superalloy Waspaloy and the damping tube is made of Inconel 718, having an operating temperature of about 550 °C, a pressure of 0.2 bar and rotates 4900 – 5200 rpm was investigated.

bonded connection. According to the data from the gas turbine, as received by the control room at failure time, the exhaust temperature was 637 °C, the rotor speed was 5200 rpm and the gas pressure was 0.2 MPa. As shown in Fig. 7, the function considered for temperature distribution was a quadratic equation for blade length, and its maximum value was 637 °C.

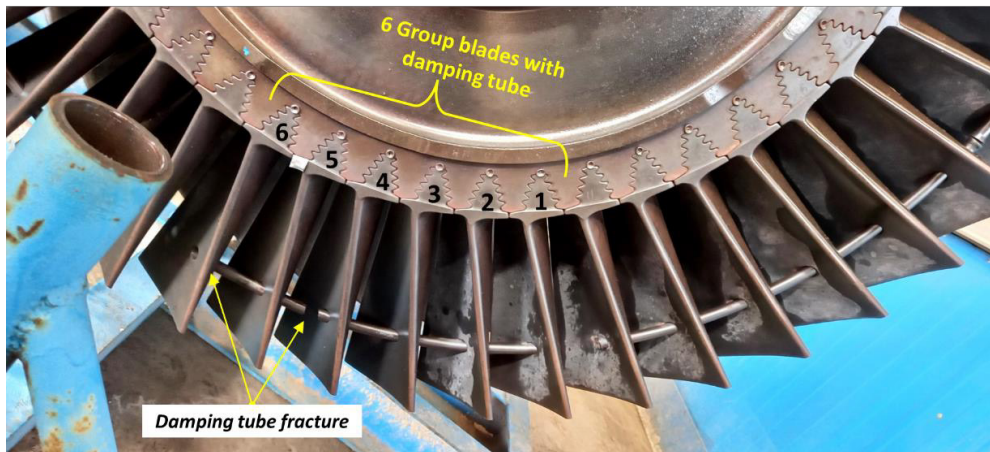
Fig. 4. The damping tube failure

is shown in Fig. 4. The failure of the damping tube has been observed in the group of six blades. This failure occurred in the left and right areas of the fifth blade.

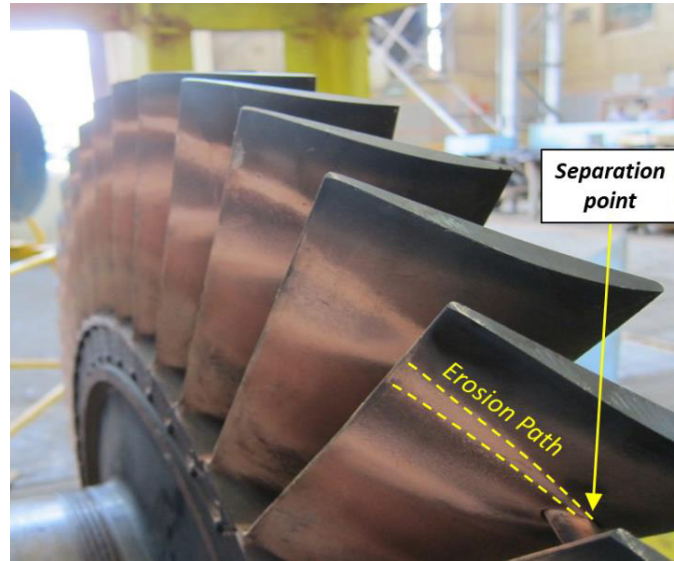
The light colors in Fig. 5 indicate the eroded suction side of the blade surfaces. The origin of erosion is the separation and turbulation of the flow due to the collision with the damping tube.

Fig. 5. Suction side eroded of first stage blades

Based on the signs of blade erosion in Fig. 5, the pitting was first created under the erosion and wear effect due to the high velocity of the gas collision. Based on the Fracture

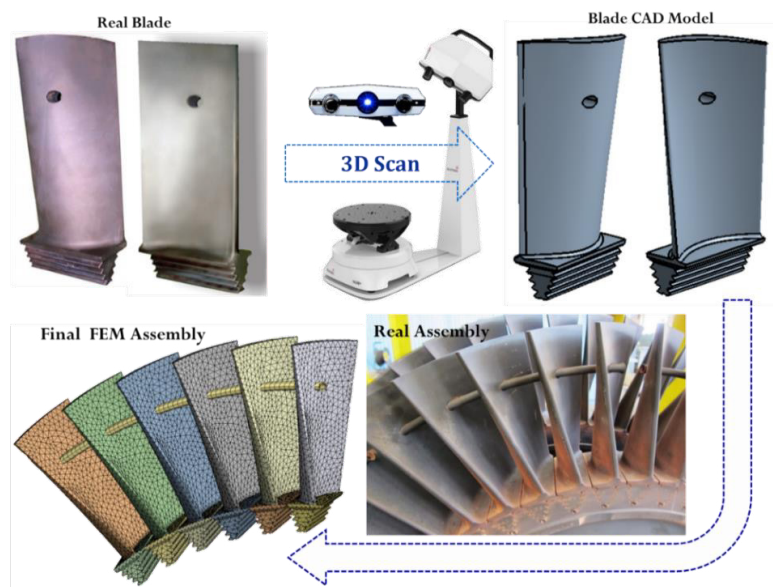
Fig. 6. A general view of digitizing process, assembled and meshed model

and assembly process are shown in Fig. 6.

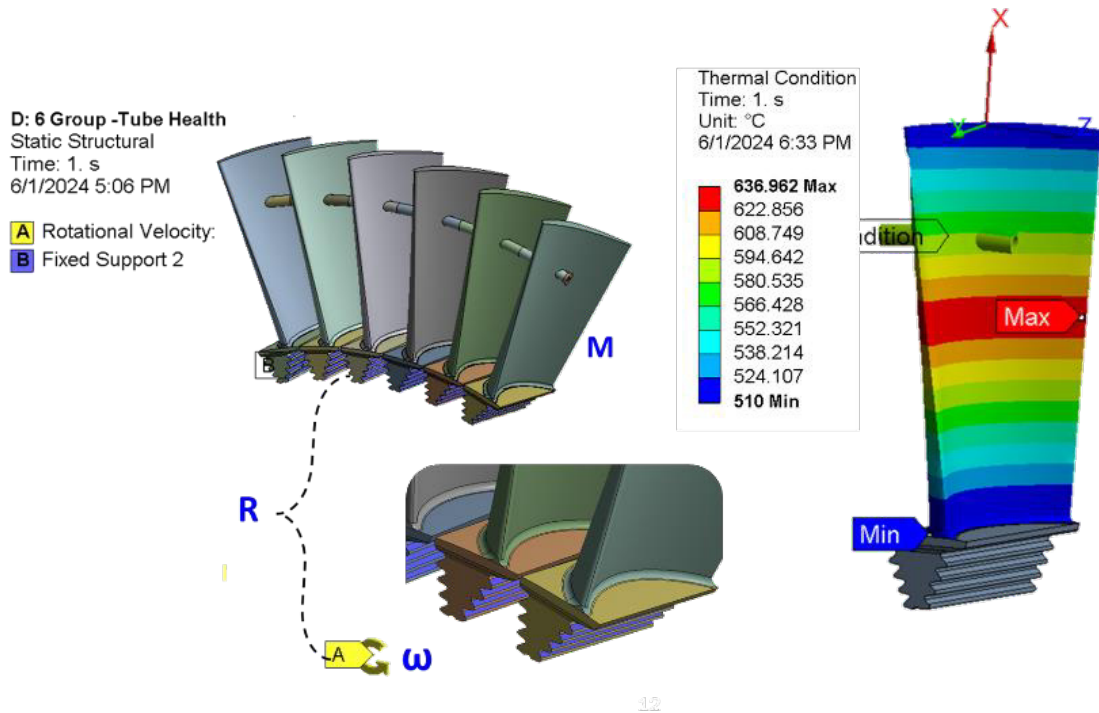
Fig. 7. Boundary conditions and loading on group blades

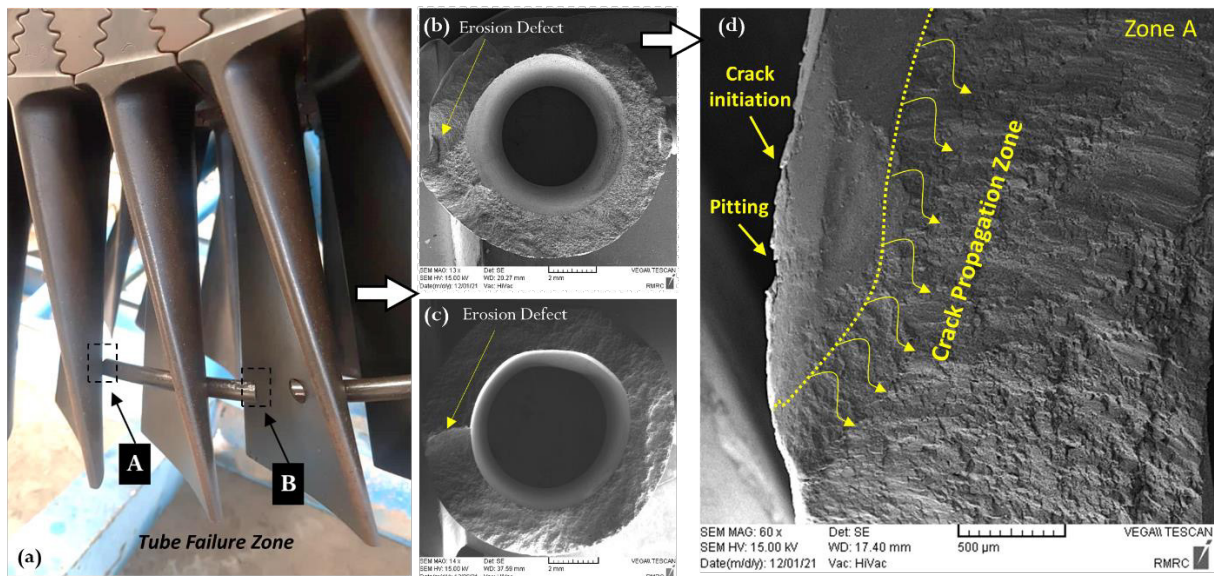
Fig. 8. Damping tube (a) failure zone, (b) Zone A (c) Zone B, (d) Magnified view of fractured surface of Zone A

surfaces shown in Fig. 8, the micro pits on the surface of the tube in location “A” lead to the microcrack initiations around it. These micro-cracks grow up to the area of the yellow dashed line and lead to the tube failure and cutting shown in Fig. 8c.

Microscopic images of the fracture section of the damping tube with 60x magnification show the effect of the pit on the outer surface of the damping tube. Around the pit, microcracks and the beach mark area, which is caused by fatigue crack growth, were observed. The presence of pits on the surface of the tube can create points with high dynamic stress concentration, which in combination with the mean stress under static loads will lead to fatigue crack growth and tube failure. As a result, the failure factor of the damping tube

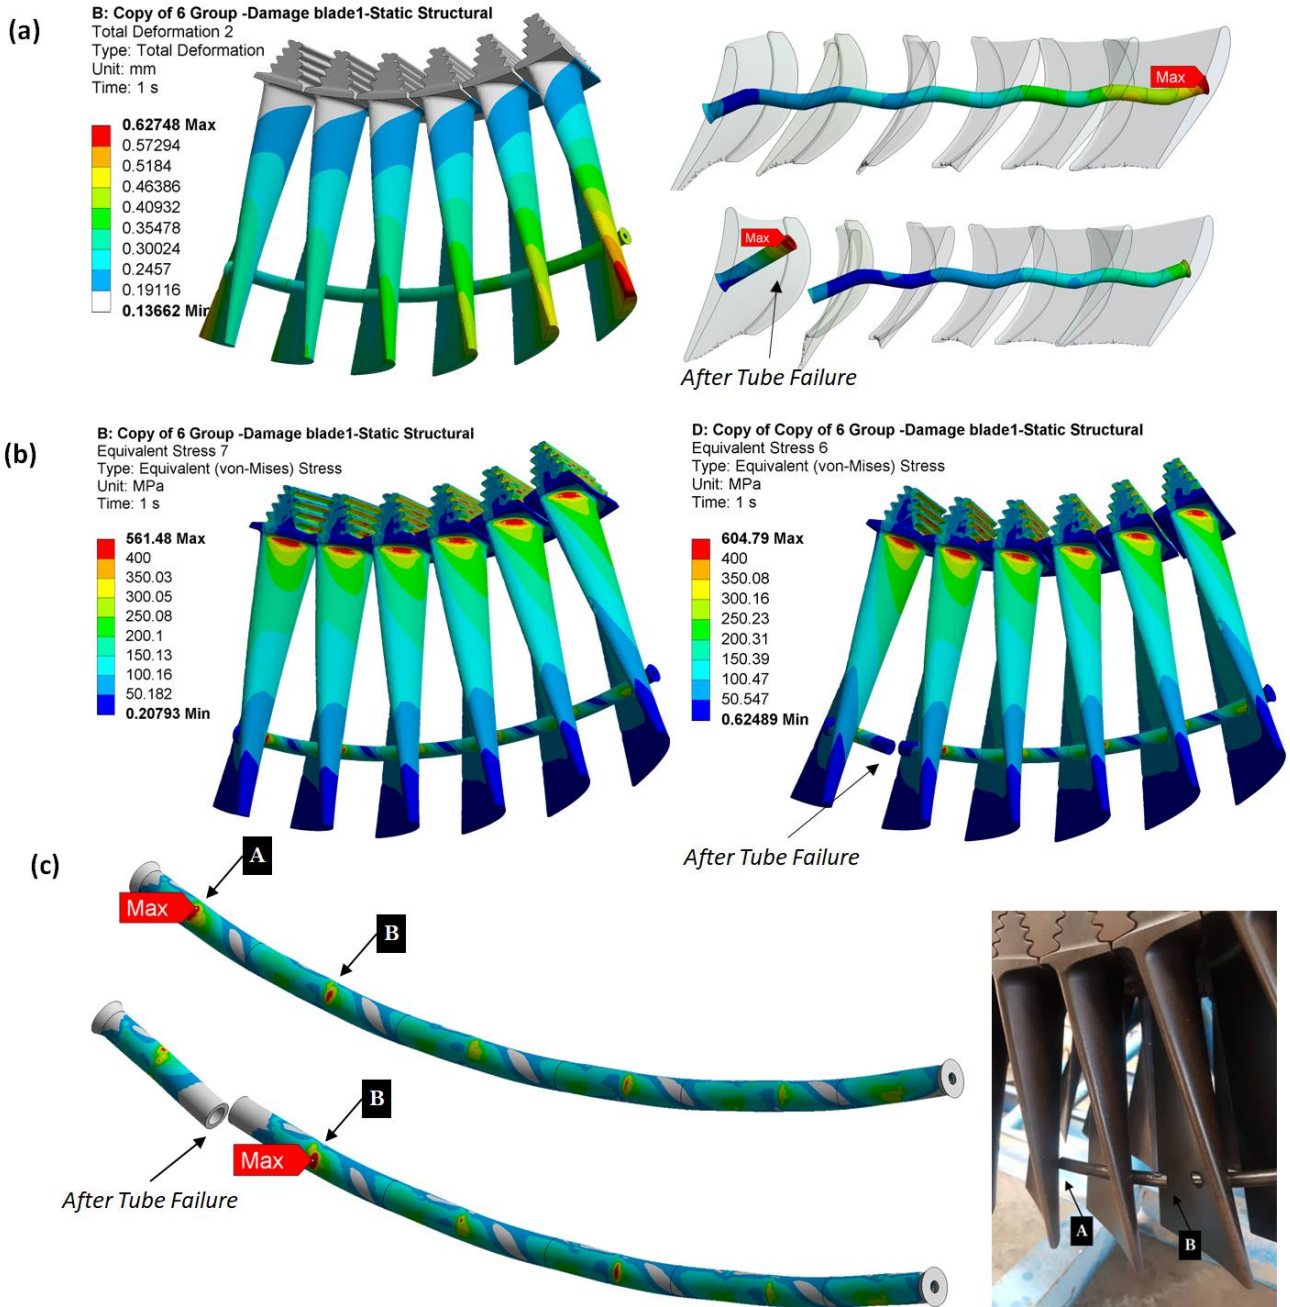
Fig. 9b shows equivalent von Mises stress distribution for the health group blade while group blades are connected with the damping tube and damage group blade under pitting and cutting in the damping tube. Clearly, the highest stress is less than the yield strength IN718 (Table 1). Therefore, the system can sustain the forces under static conditions with no major crack. Fig. 9c shows that if the tube is cut in location A, the place of maximum stress will move to location B. Considering the closeness of von Mises equivalent stress values of the health and damage tube in Fig. 9b, it is concluded that the main purpose of the damping tube was not the task of control and reduction of static stress, and its task is something else. The most important candidate parameter for the philosophy of using the damping tube between the blades is to control the vibrations of the blades, which will be discussed further.

Fig. 9. Static analysis of health and damage tube (a) Total deformation of, (b) Equivalent Von-Mises stress of health and damage tube (c) stress concentration.

The static stress analysis shows that in the case where the damping tube is healthy, the Von Mises equivalent stress is 561 MPa. In the event of erosion on the surface of the damping tube, the Von Mises stress increases up to 963 MPa. Considering that the yield stress of the IN718 alloy is 1027 MPa, it can be concluded that the pitting caused by erosion is the main cause of the failure of the damping tube.

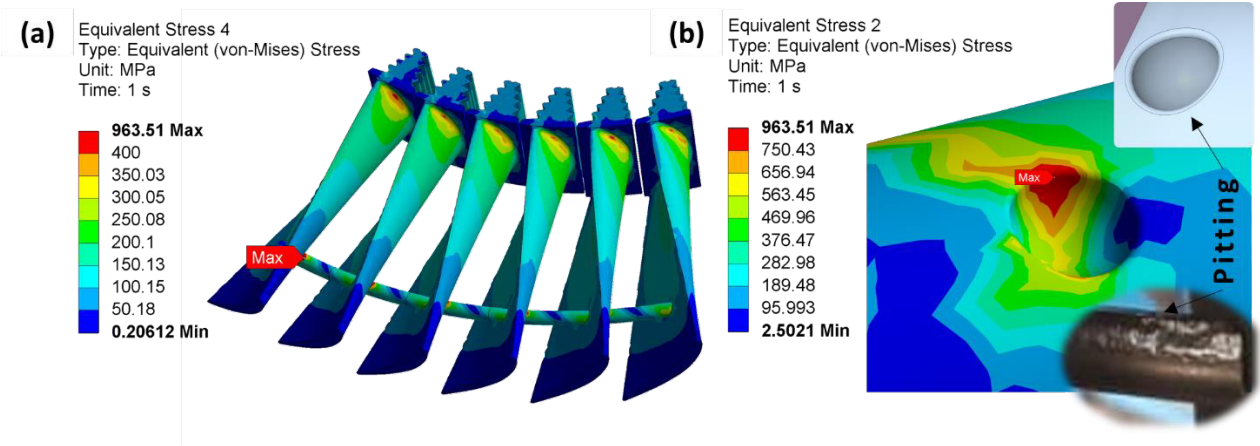
The pitting created by the erosion caused by the separation of the fluid flow on the surface of the tube creates a high-stress area close to the yield stress. This area is prone to fatigue crack growth and failure. Fig. 10 shows the Von Mises stress contour in the pitting formation area.

Fig. 10. Equivalent Von-Mises stress of (a) group blades, (b) pitting on damping tube

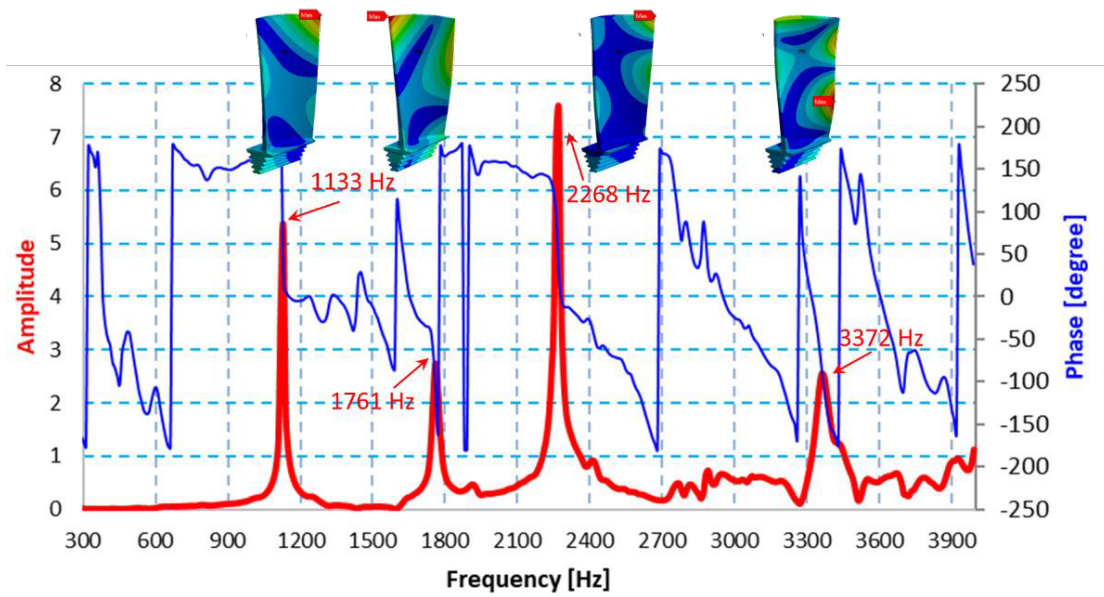
One PCB-353B15 miniature piezoelectric uniaxial acceleration sensor and a 2KN impact hammer are used to perform modal testing. The comparison between the test (Fig. 11) and the FEM model (Fig. 12) shows that the frequency difference of the first mode is about 2% and the second mode is about 1%, which shows that the modeling, material definition, and meshing of the blade have been done with good accuracy.

Fig. 11. FRF of a free-free single blade

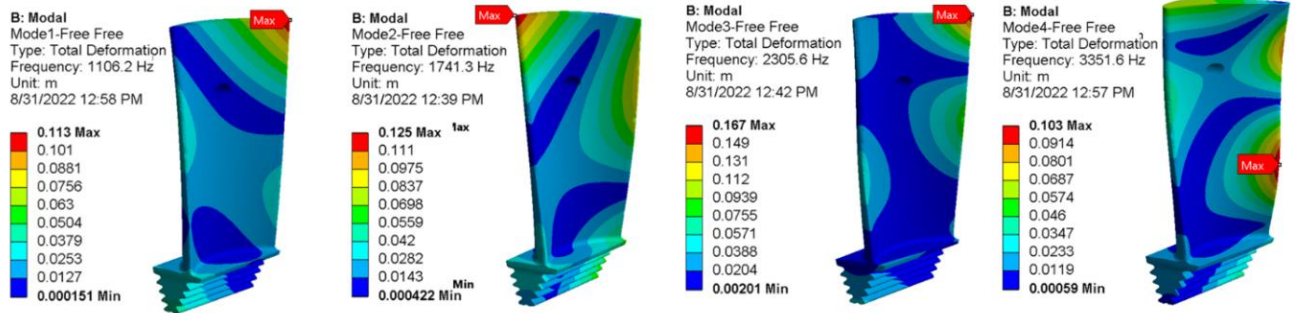
Fig. 12. FEM modal result of a free-free single blade

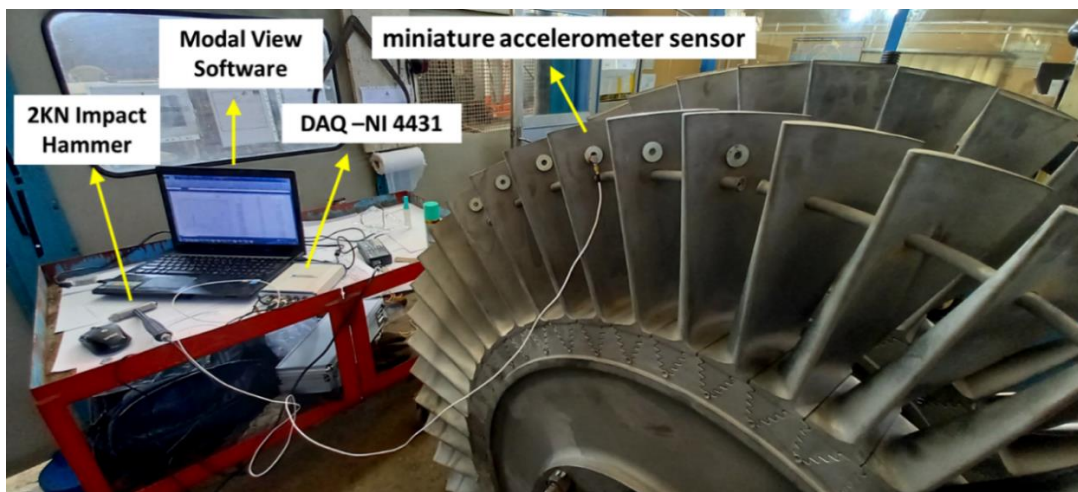
Due to the complete assembly of the rotor and the existence of non-linear factors of surface contact, the modal test was only able to measure the natural frequency of the first bending mode of the group blades (Fig. 13). The results of modal test and finite element simulation for the first bending mode are shown in Fig. 14.

Fig. 13. Group blades assembly Vibration test setup

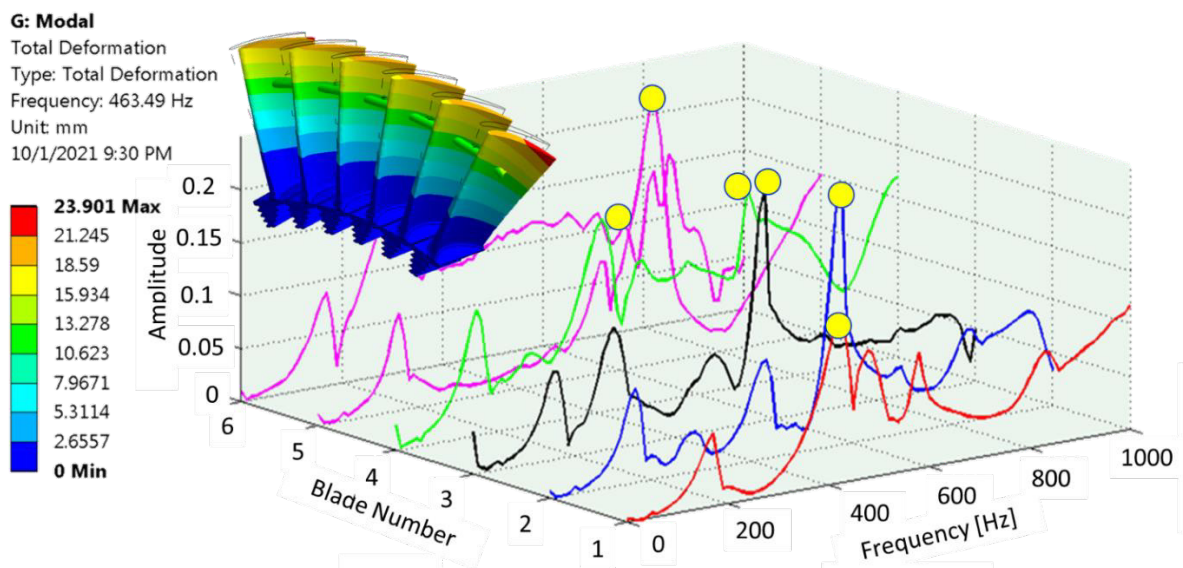
The measured value of the frequency for the group-blades is about 430 Hz (yellow points) and the value calculated by the FEM is 463.5 Hz. The 6% difference between the modal test and the FEM shows the high accuracy of modeling, definition of boundary conditions and material.

Fig. 14. Comparison FEM and test results of 1st natural frequency for group blades

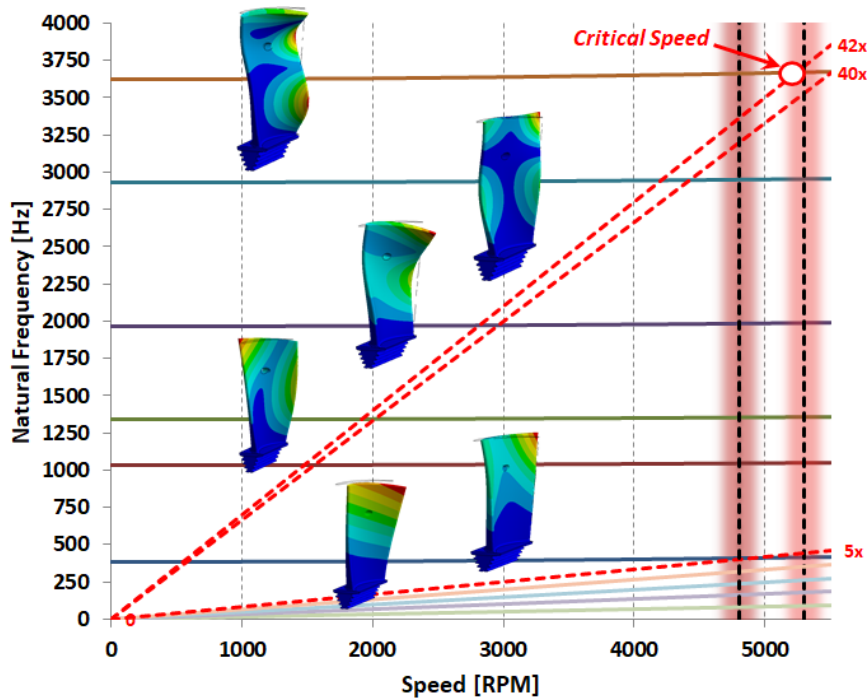
Fig. 15. Campbell diagram of single blade

The Campbell diagram for a single blade and a group of blades coupled to each other with a damping tube is shown in Fig. 15 and Fig. 16. The Campbell diagram is an overall view of regional vibration excitation that can occur on an operating system. The Campbell diagram can be generated from machine design criteria or from machine operating data.

For the single-blade mode, which somehow indicates the lack of connection of the damping tube between the blades, two natural frequency interferences with excitation harmonics have occurred in the working speed range. One of the interfere is related to the first bending mode with the fifth harmonic and the other interference is related to the sixth mode with the 42nd harmonic, which is related to the passing frequency of the second stage stator blades.

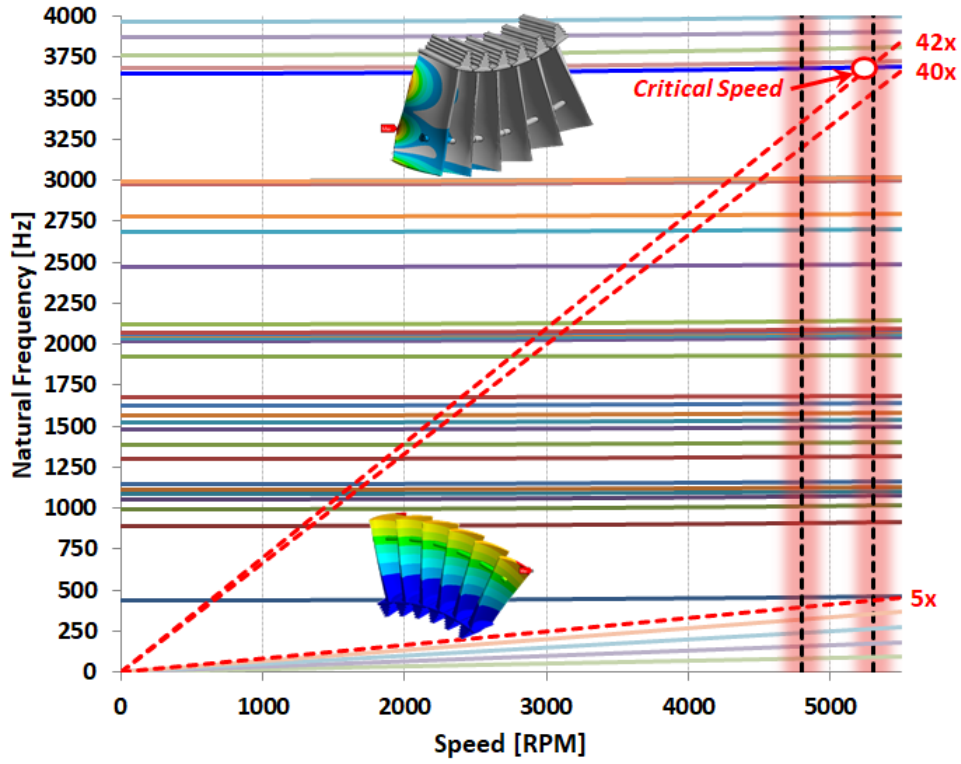
Fig. 16. Campbell diagram of group blades

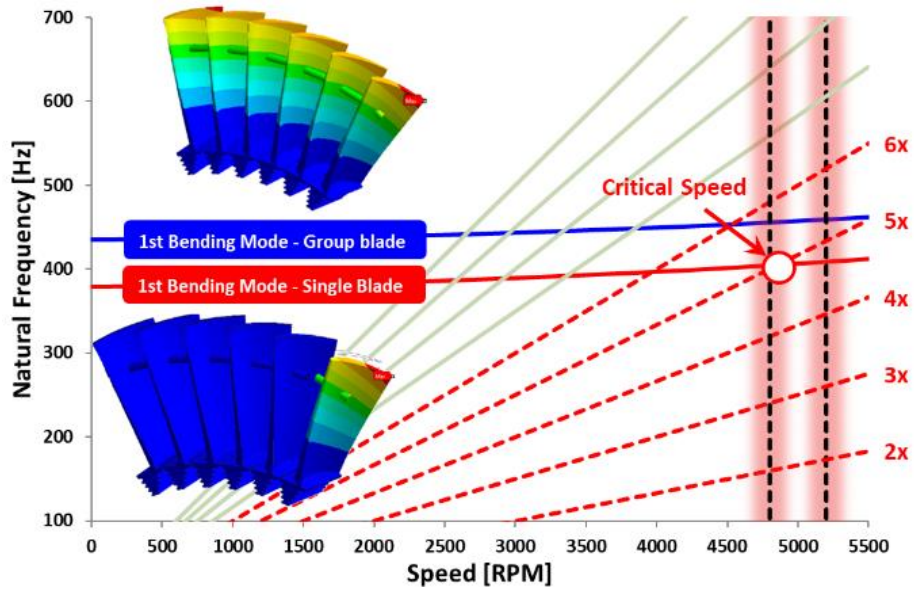
is shown in Fig. 17. Damage in the damping tube causes the connection between the vanes to break. So that a single blade will have a lower frequency than the group of blades. The results of the diagram show that the cutting of the tube causes a 30% decrease in the frequency of the first bending mode of the blade in such a way that it will interfere with the fifth harmonic of the excitation in the range of 4900 rpm.

Comparing the Campbell diagram of the group of blades in healthy and damaged conditions, it is clear that the cut of the connection between the blades will lead to the resonance of the blade in the first mode with the fifth harmonic.

Fig. 17. Comparison of Campbell's diagram of the first mode of the blade group in the state of healthy and damaged tube

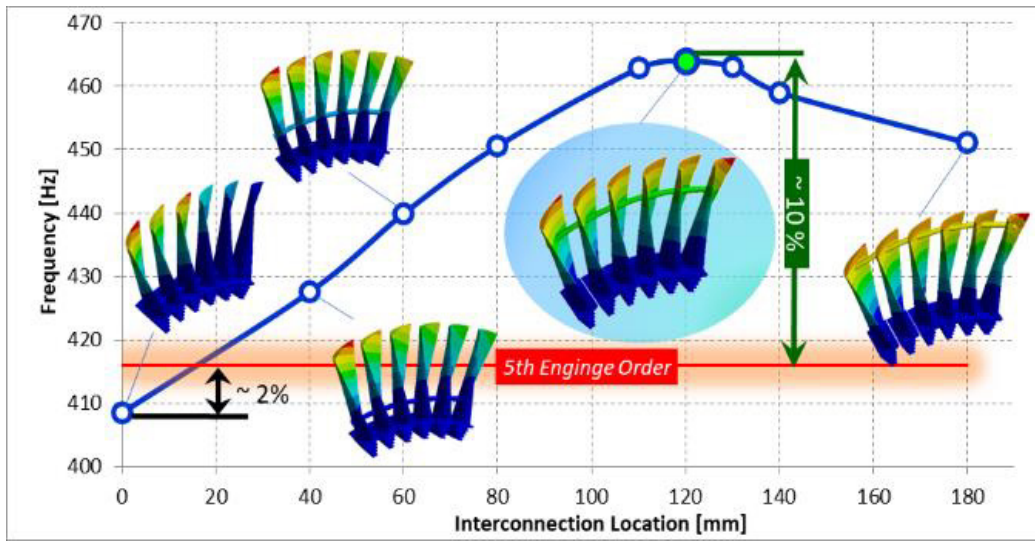
Based on Fig. 18 the distance of the tube to about 70% of the hub blade increases the frequency of the first bending mode and for a distance of more than 70% reduces the natural frequency. The main reason for the decrease in blade natural frequency at the tube position in the last 30% is the effect of the mass of the tube at the blade tip or the predominant effect of the concentrated mass relative to the stiffness effect.

Fig. 18. The 1st bending natural frequency versus interconnection location

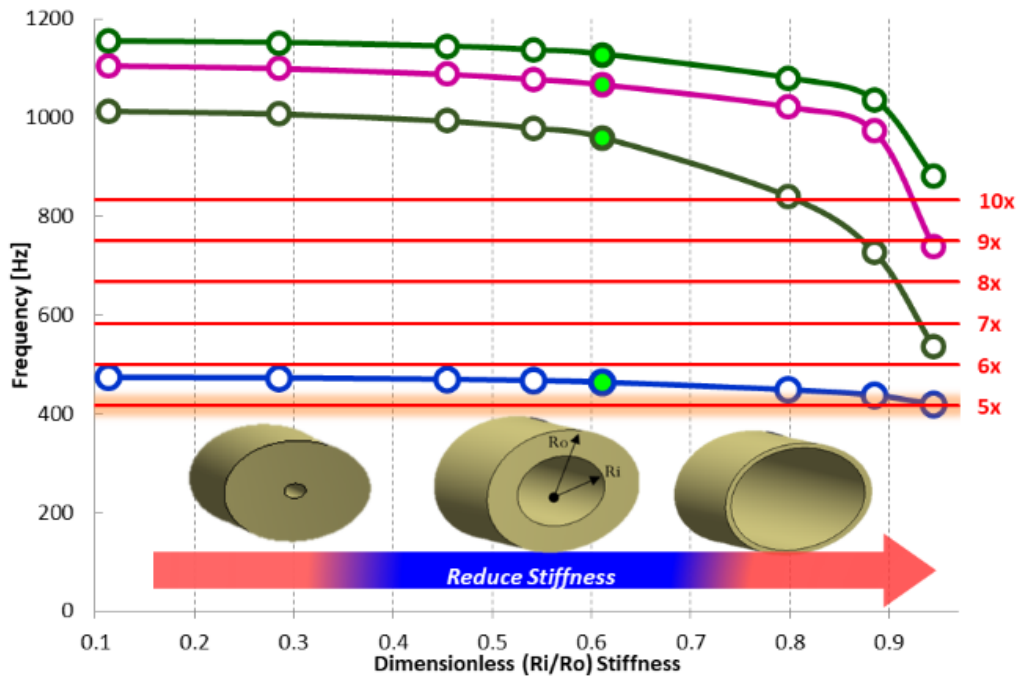
Fig. 19 shows increasing the diameter ratio reduces the

Fig. 19. The 1st four natural frequencies versus interconnection stiffness

stiffness of the connection between the blades. Reducing the difference between the inner and outer diameters reduces the natural frequencies of the blades. The best design is a diameter ratio of 0.6, which is in the safe range of resonance for the first mode.

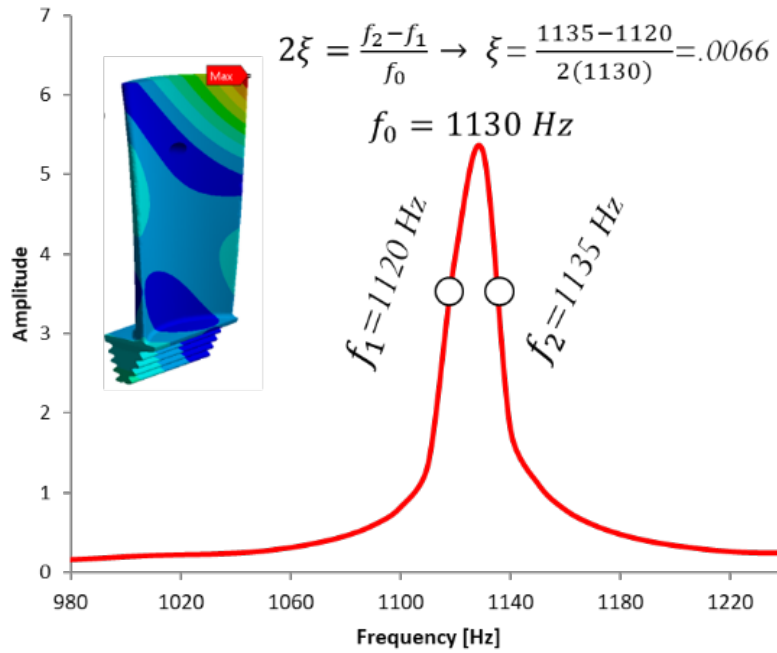
Fig. 20. Damping Ratio of the single blade

The damping ratios of blades from impact test measurement for a single blade and group blades are both calculated by the half-power bandwidth method. The principle of the half-power bandwidth method is that we need to obtain the resonance peak of the frequency response of the system, and then damping parameters of the system are obtained by using the resonance frequency and two frequency points with $1/\sqrt{2}$ times decrease in the resonance amplitude near resonance peak, so the solution formula can be expressed as following[35].

The ξ is the damping ratio, resonance frequency, and the two frequency values which are $1/\sqrt{2}$ times the resonance peak at the two sides of resonance frequency as shown in Fig. 20 for single blade and Fig. 21 for group-blades. The damping ratio calculated by the half-power method for a single blade is 0.006 and 0.058 for a group of blades. The damping tube has increased the damping ratio by ten times. Analyzing the effects of the damping ratio on dynamic stresses and vibration amplitude is presented in the harmonic analysis section.

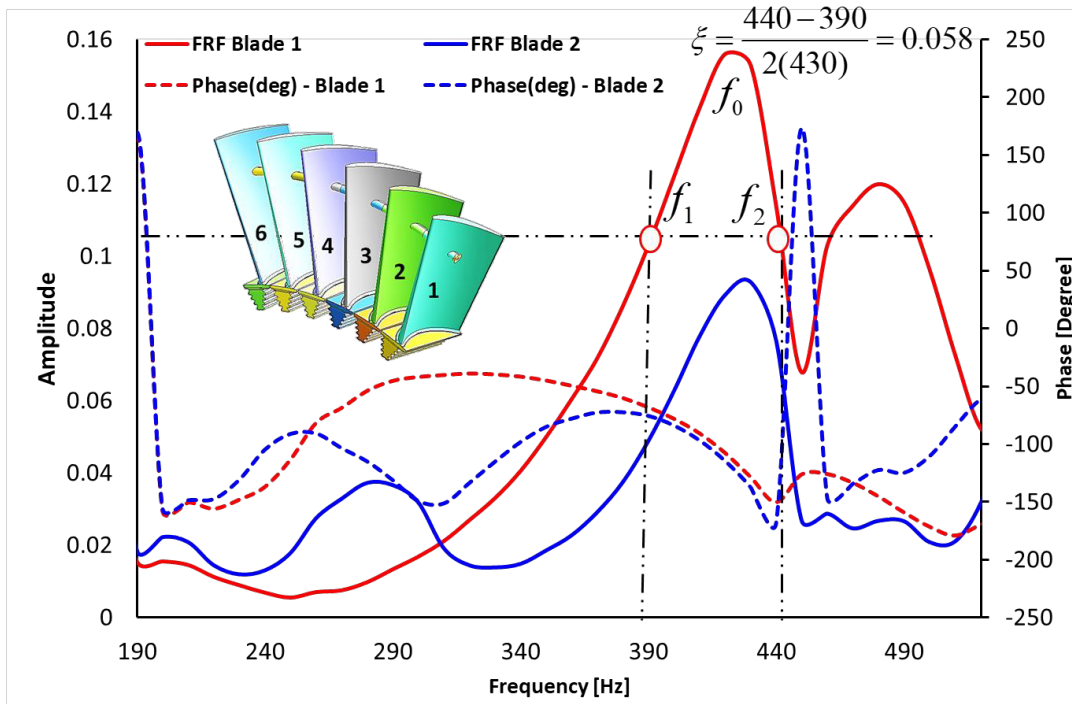
Fig. 21. Damping ratio of group blades

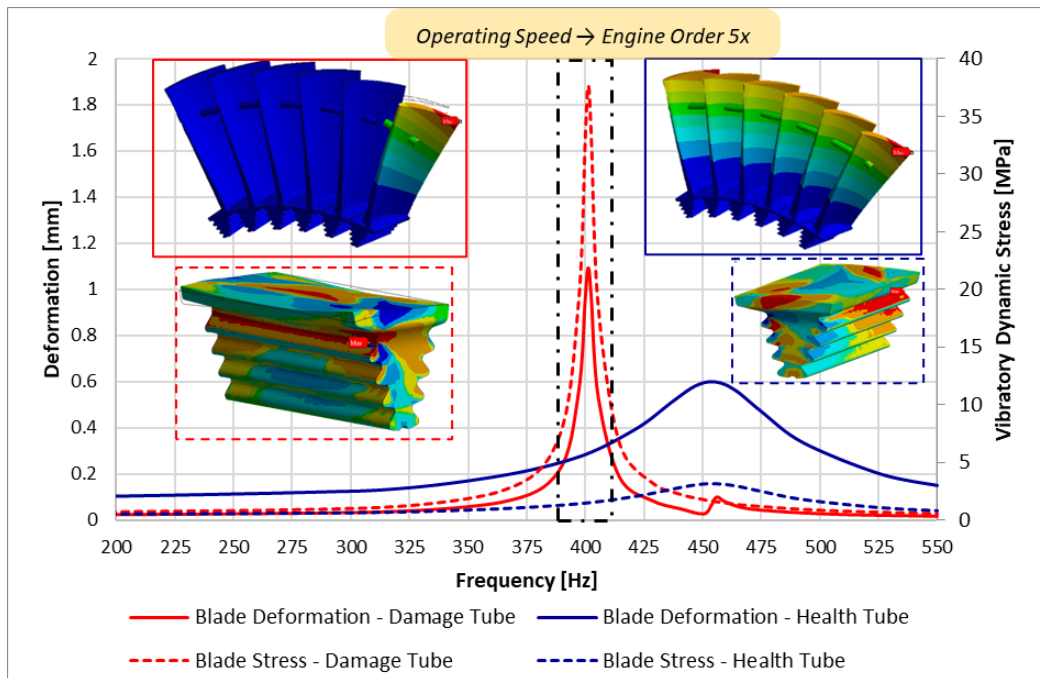
Also, the dynamic stresses in the first mode for a single blade and a group-blades are shown with red and blue dashed

Fig. 22. The graph of frequency response for 1st bending mode with the excitation fifth harmonic per-revolution of the rotor

lines in Fig. 22, respectively. The place of stress concentration in the blade fir tree root will be prone to high cycle fatigue cracks in the first mode in case of resonance.

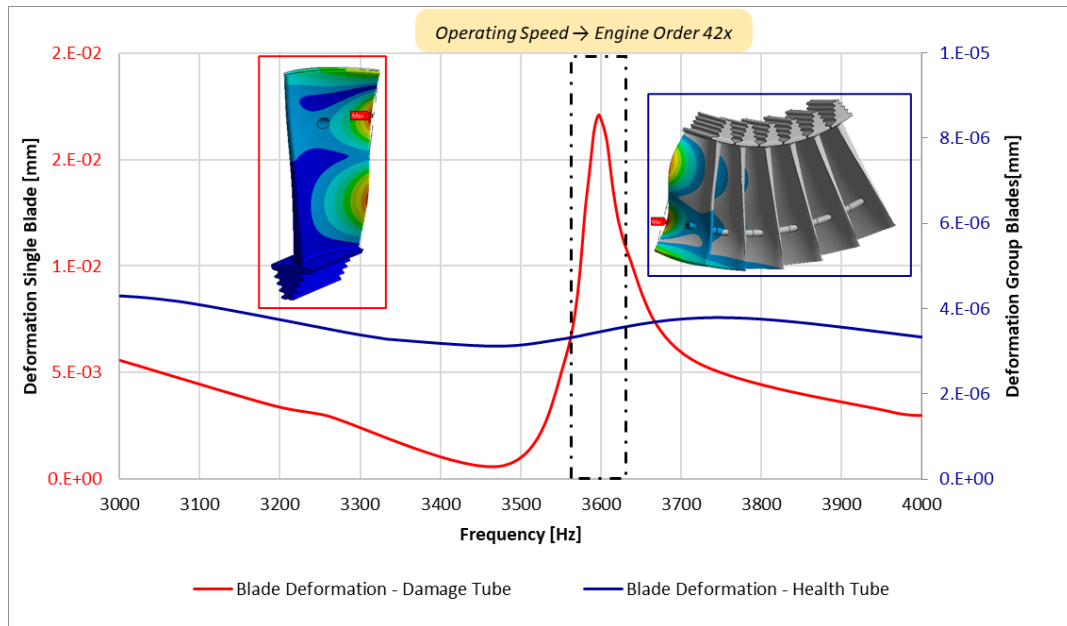
Fig. 23. The graph of frequency response for 6th bending mode with the excitation fifth harmonic per-revolution of the rotor.

The frequency response diagram for the frequency of the 6th mode, which resonates under the effect of the 42nd harmonic, is shown in Fig. 23. A single blade is shown with a red line, and a group blade is shown with a blue line. In general, the amplitude in this mode is very low, and it seems that it is not a critical mode from the point of view of the OEM.
